Test Summary

High Speed Running with AlloyGator Rim Protectors

Customer: Curt Rathbone
Alloygator Ltd
Unit 3 Crooks Lane Business
Park
No 7 Crooks Lane
Studley
Warwickshire
B80 7QX

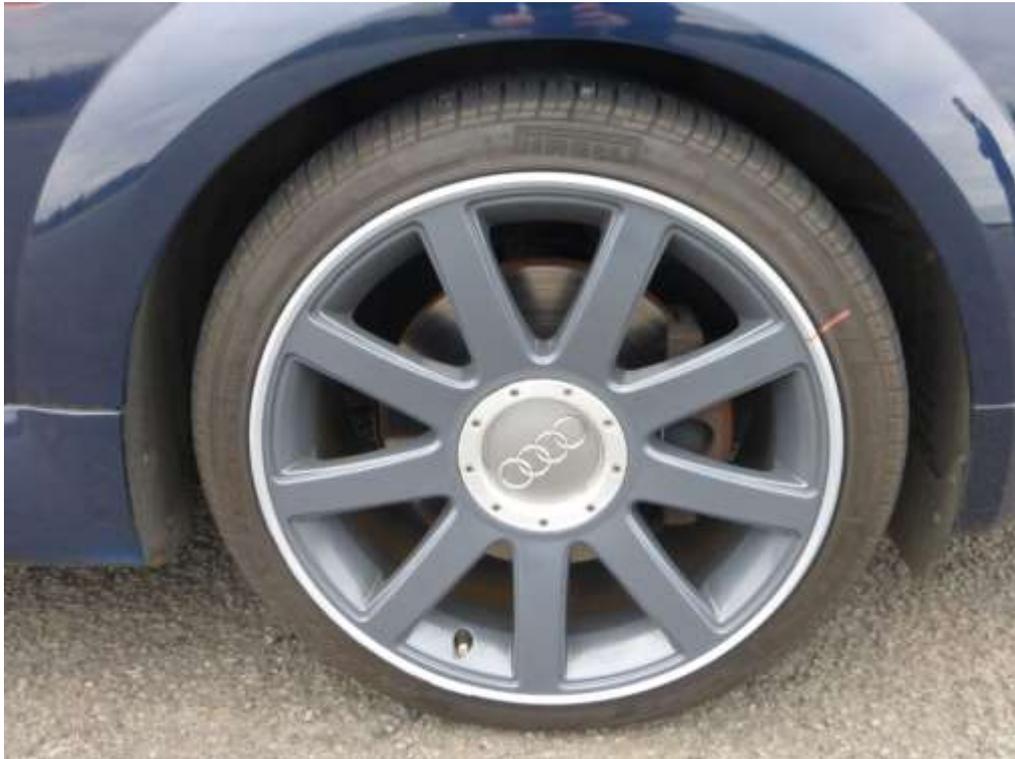
AlloyGator rim protectors. These were inserted and fixed between the tyres and rims of the wheels by AlloyGator. An example of an AlloyGator fitted to a wheel is shown in Figure 1.

Figure 1: An AlloyGator rim protector fitted to a wheel

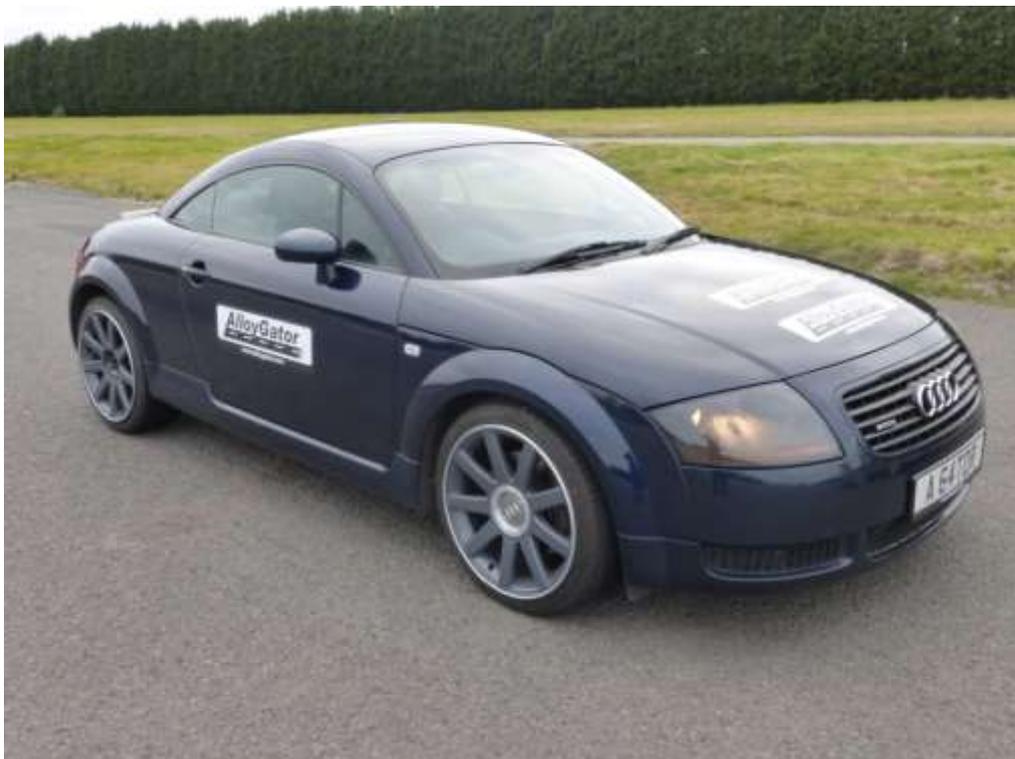
The test vehicle was an Audi Quattro Mark 1 TT (Registration: A 64TOR) as shown in Figure 2.

Figure 2: Test vehicle with AlloyGator rim protectors fitted

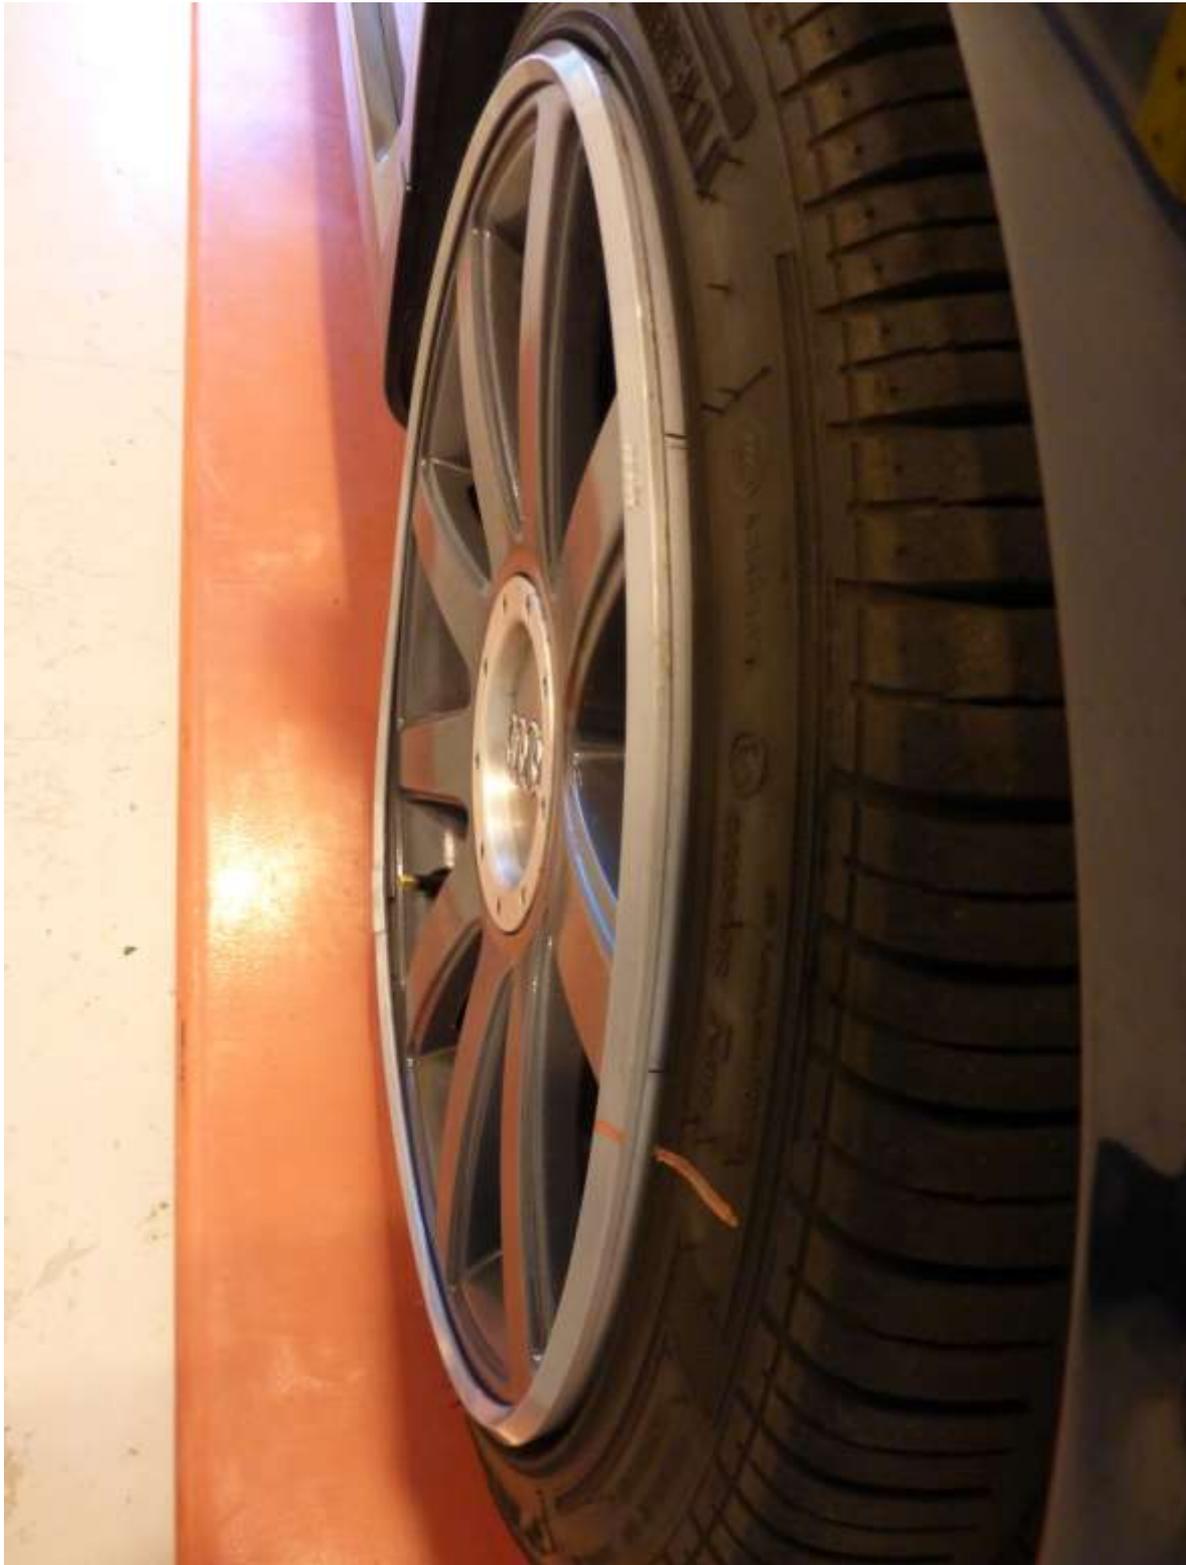
- The AlloyGator on the RHS front wheel (with Pirelli P Zero tyre) had moved as shown in Figure 3.
- There was no movement to the AlloyGators on the LHS front and RHS rear wheels.
- There was no loss of pressure to any of the tyres.

Figure 3: Movement to the AlloyGator rim protector on the RHS front wheel following completion of Test 2

Prior to conducting this test, AlloyGator supplied a replacement Bridgestone Potenza tyre to replace the tyre with the damaged bead. This new tyre was fitted to the rim and then an AlloyGator rim protector was fitted to this wheel. The AlloyGator rim protector that had moved during Test 1 was re-fitted to its correct position.

AlloyGator need to inspect the wheel (rim, tyre and AlloyGator) on which the AlloyGator rim protector moved in order to ascertain the reason why this movement occurred.

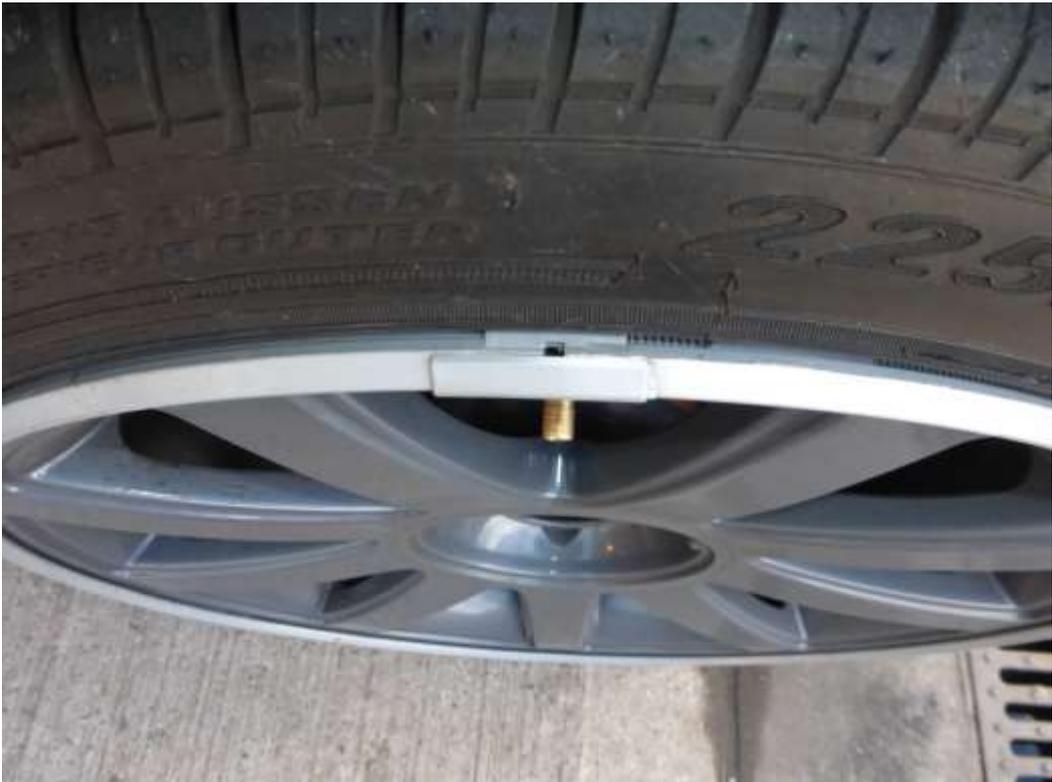
- Part of the AlloyGator on the LHS rear wheel (with Pirelli P Zero tyre) had moved outwards by approx. 3 mm, as shown in Figure 4 (Note: This was the same wheel that was originally fitted on the RHS front of the vehicle, on which the AlloyGator had moved during Test 2).
- There was no movement to any of the AlloyGators fitted to the three other wheels.
- There was no loss in pressure to any of the tyres.

Figure 4: Movement to the AlloyGator on the LHS rear wheel following completion of Test 4

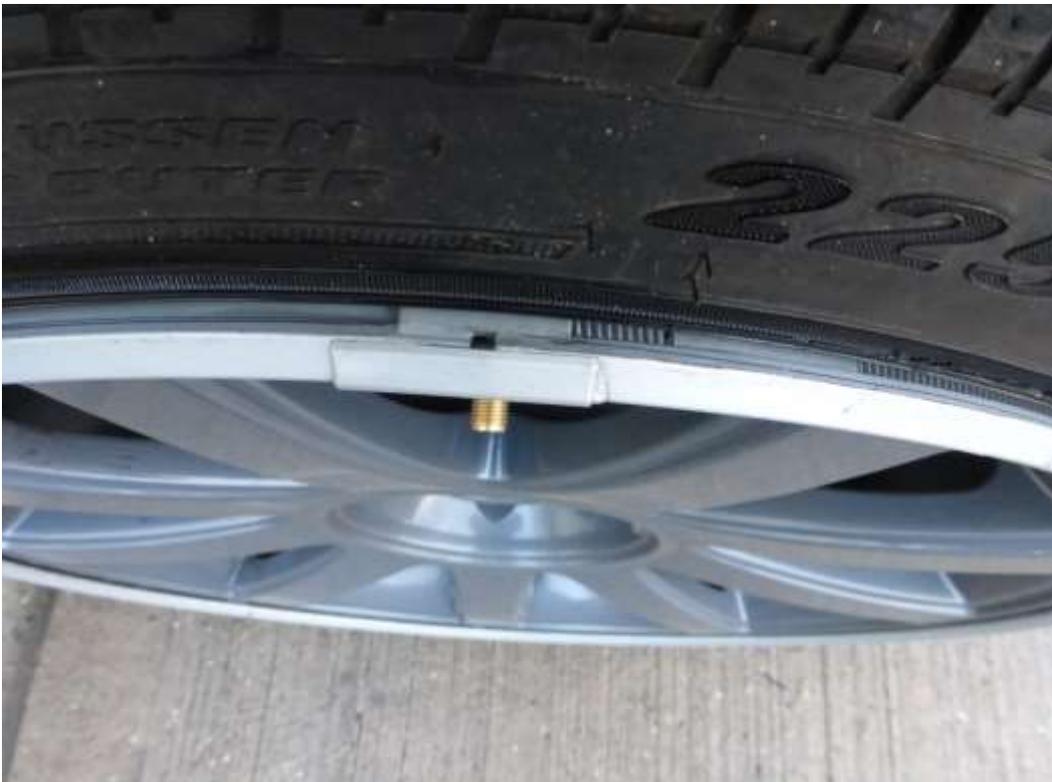
- Part of the AlloyGator on the LHS rear wheel (with Pirelli P Zero tyre) had moved outwards by another 2 mm (approx.). This meant that during Tests 4 and 5 this AlloyGator had moved outwards by a total of 5mm (approx.). The AlloyGator is shown post-test in Figure 5. (Note: This was the same wheel that was originally fitted on the RHS front of the vehicle, on which the AlloyGator had moved during Test 2).
- There was no movement to any of the AlloyGators fitted to the other three wheels.
- There was no loss in pressure to any of the tyres.

- When an AlloyGator is fitted to a tyre that already has a damaged bead, it can highlight this problem as was observed during the preparation for Test 2.
- There was movement to the same AlloyGator during Tests 2, 4, and 5. The movement was always on the same wheel (same rim, fitted with the same Pirelli P Zero tyre). It occurred when the wheel was fitted to the RHS front (Test 2) of the car and also to the LHS rear (Tests 4 & 5) of the car.
- There was no loss of tyre pressure to any of the wheels fitted with AlloyGator rim protectors during the testing.

Figure 5: Total movement to the AlloyGator on the LHS rear wheel following completion of Tests 4 and 5
