Test Results

Tyre rim roll-off tests with alloy wheel protectors

> Allovgator Vehicle Dynamics

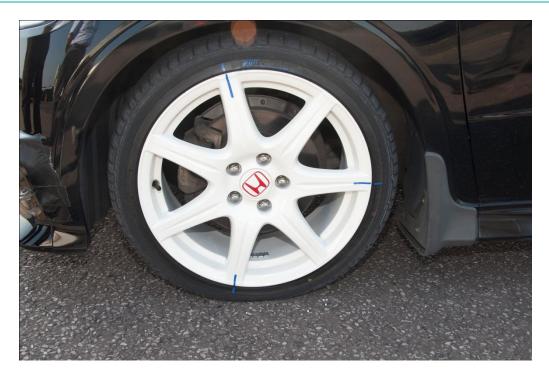
Figure 1 – 'Tyre 1' after Testing at 0.8 Bar

Table 1; Tyre Rim Roll-Off Results, 'Tyre1'		
Tyre Pressure	Observations	
1.4 Bar	No rotation of tyre	
1.2 Bar	No rotation of tyre	
1.0 Bar	No rotation of tyre	
0.8 Bar	No rotation of tyre

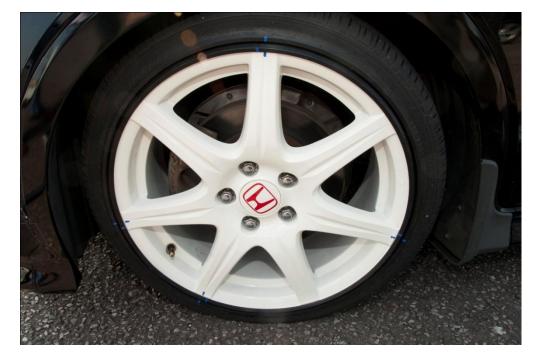
Figure 2 - 'Tyre 2' after Testing at 1.0 Bar

Small rotation of rim protector (Figure 2) Larger rotation of rim protector (Figure 3)

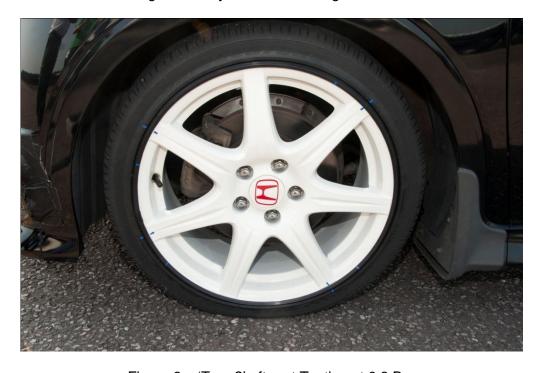
Figure 3 – 'Tyre 2' after at Testing at 0.8 Bar

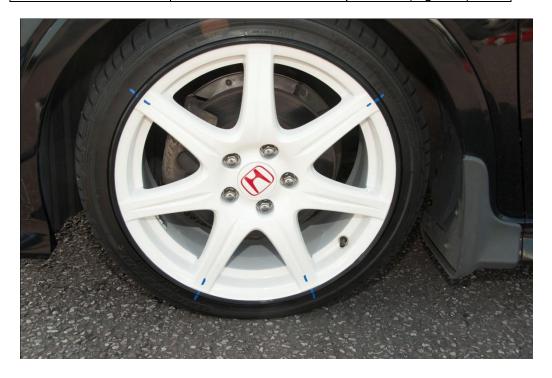
Figure 4 – 'Tyre 3' after Testing at 1.0 Bar

Table 3; Tyre Rim Roll-Off Results, 'Tyre3'		
Tyre Pressure	Observations	
1.4 Bar	No rotation of tyre or rim protector	
1.2 Bar	No rotation of tyre or rim protector	
1.0 Bar	No rotation of tyre or rim protector (Figure 4)	
0.8 Bar	Small rotation of rim protector (Figure 5)

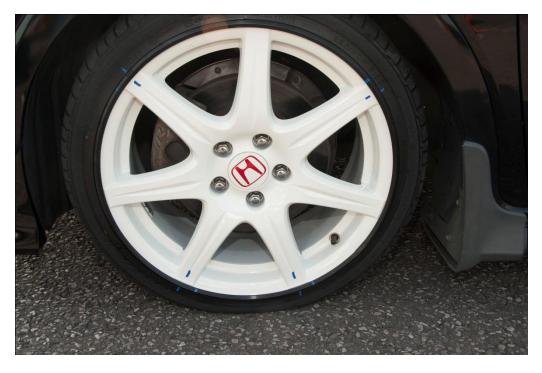
Figure 5 – 'Tyre 3' after Testing at 0.8 Bar
